BIOLOGICAL RESOURCES AND WETLAND DELINEATION REPORT

LOS WILLOWS MAJOR USE PERMIT

P03-127 / LOG NO. 96-02-029A

FALLBROOK, CALIFORNIA

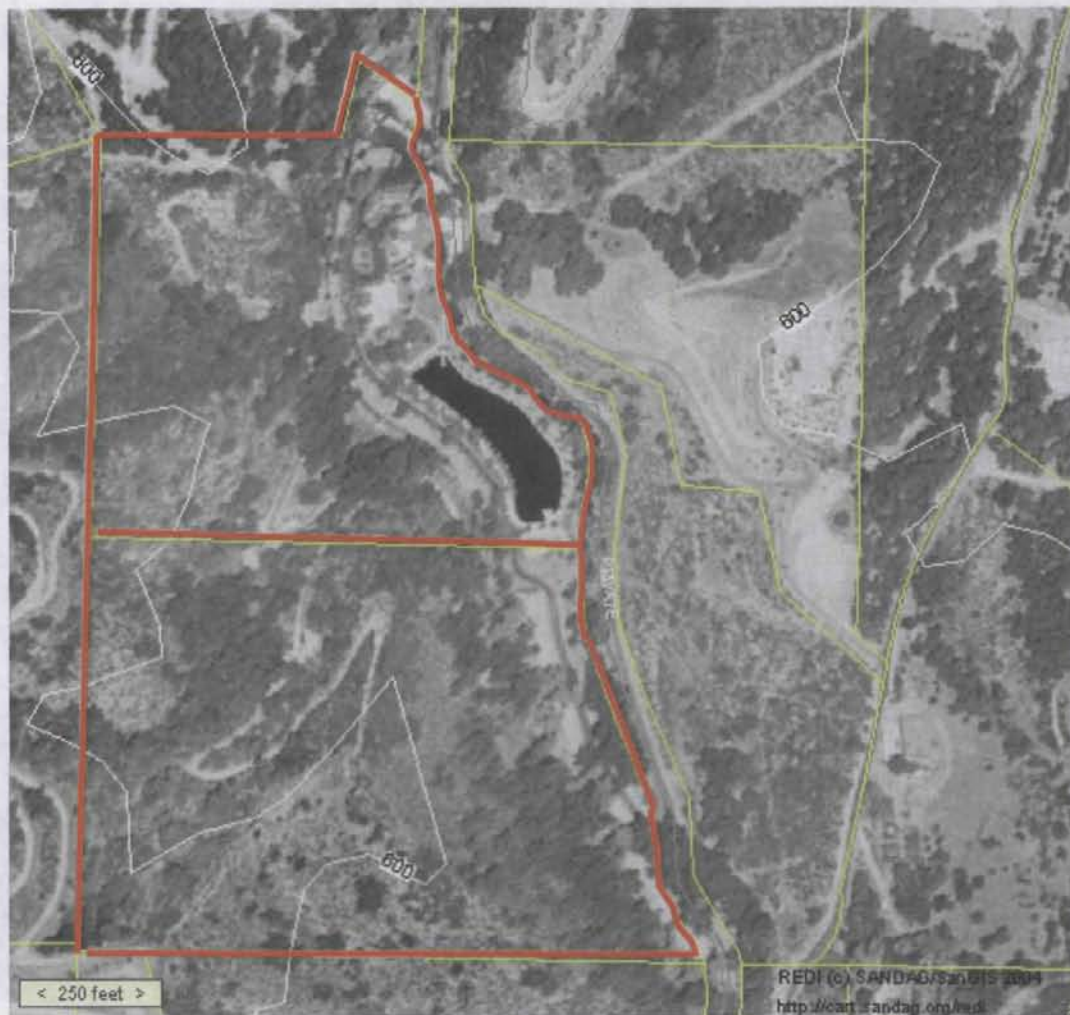
Figure 5. Close-up satellite photograph of project site (from SANDAG/SanGIS 2004), showing parcel boundaries for project site (outlined in red) and adjacent properties in yellow. Photo was taken prior to 1997. Top of photo is true north.

Mixed Chaparral on the site, burning many live oaks and removing understory. Before the fire, the steep slopes were covered with native vegetation, a mosaic of Granitic Southern Mixed Chaparral, Diegan Coastal Sage Scrub, and Coast Live Oak Woodland. The surrounding area was also burned and is mostly developed with agriculture and low-density residential properties (Figures 4 and 5, and photographs in Appendix C).

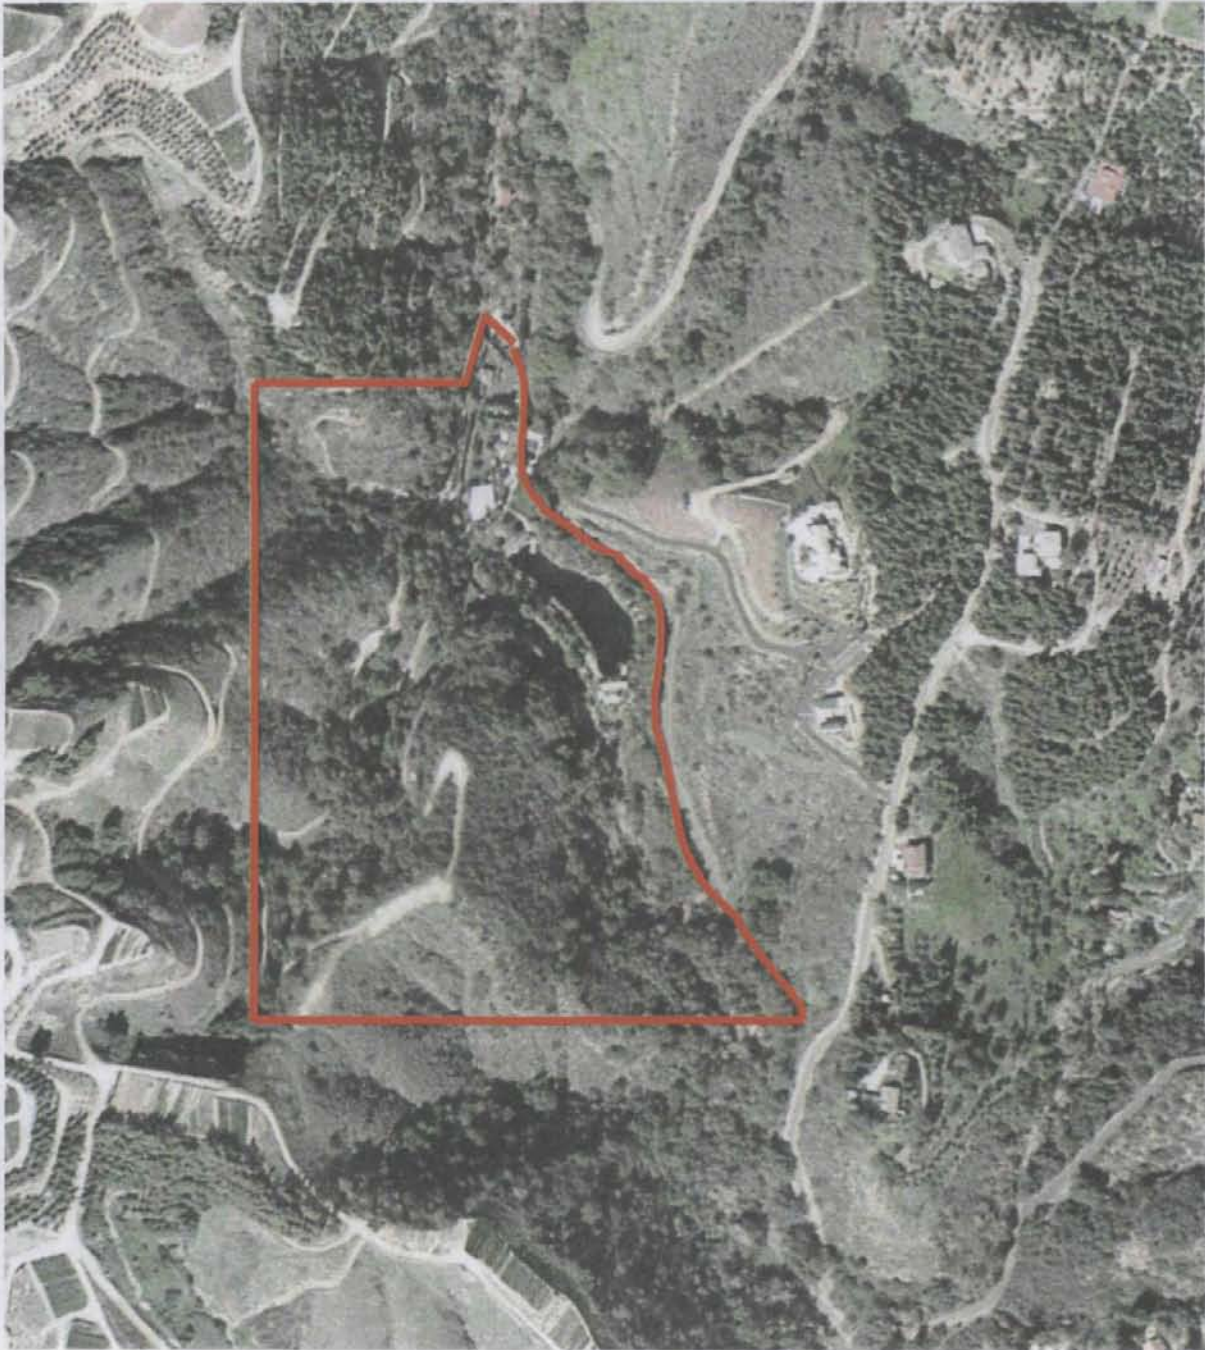
Photograph 1. Aerial image of the project site prior to the Rice Fire, bounded in red.

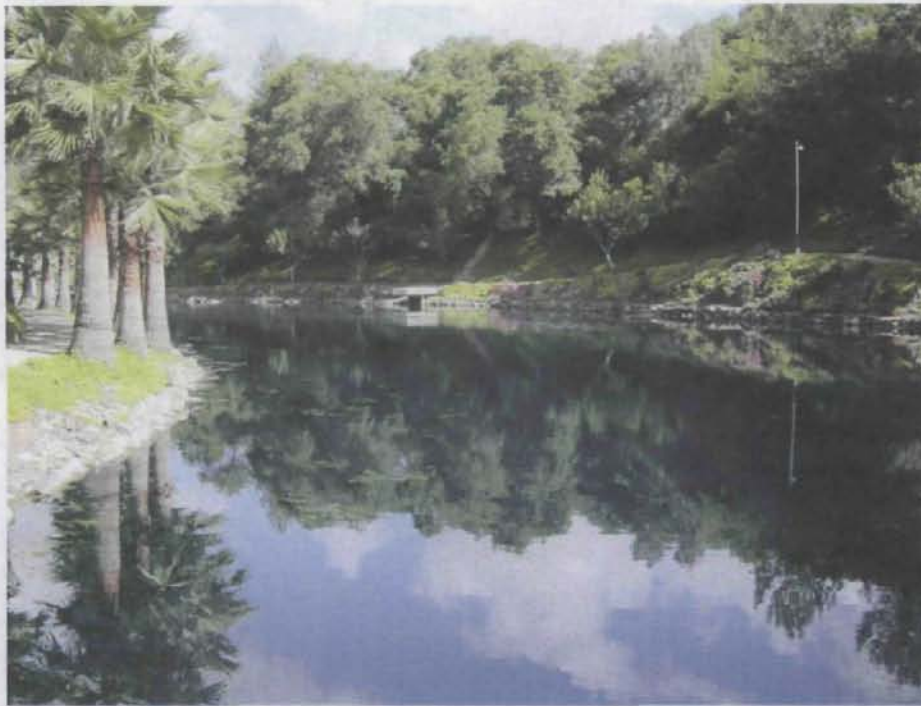
Photograph 2. View of the artificial pond in the center of the spa/wedding complex.

This habitat is restricted to the artificial pond located within the developed area. It is entirely surrounded by sidewalk and grass areas and lacks any features that would support sensitive wetland species. The pond is stocked with fish by the California Department of Fish and Game, and is occasionally used during wedding events. A total of 0.61 acres of this habitat type occur on-site.

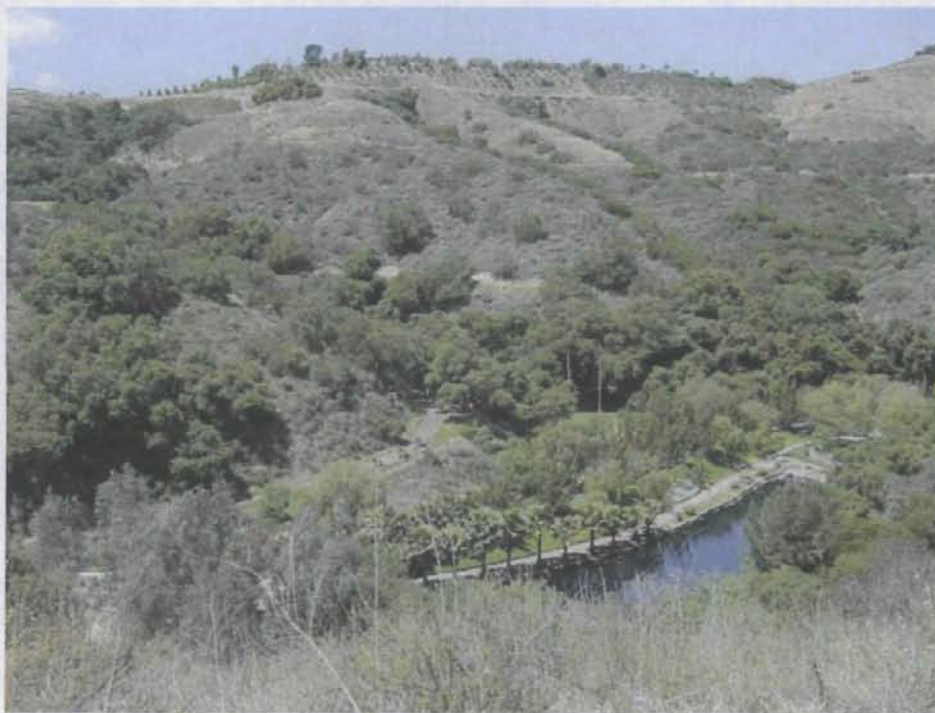
Photograph 3. View looking northwest from the parcel east of the project site. Photo taken prior to the Rice Fire. The pond is in the foreground. The vegetation mosaic of Coastal Sage Scrub, Granitic Southern Mixed Chaparral, and Coast Live Oak Woodland can be seen.

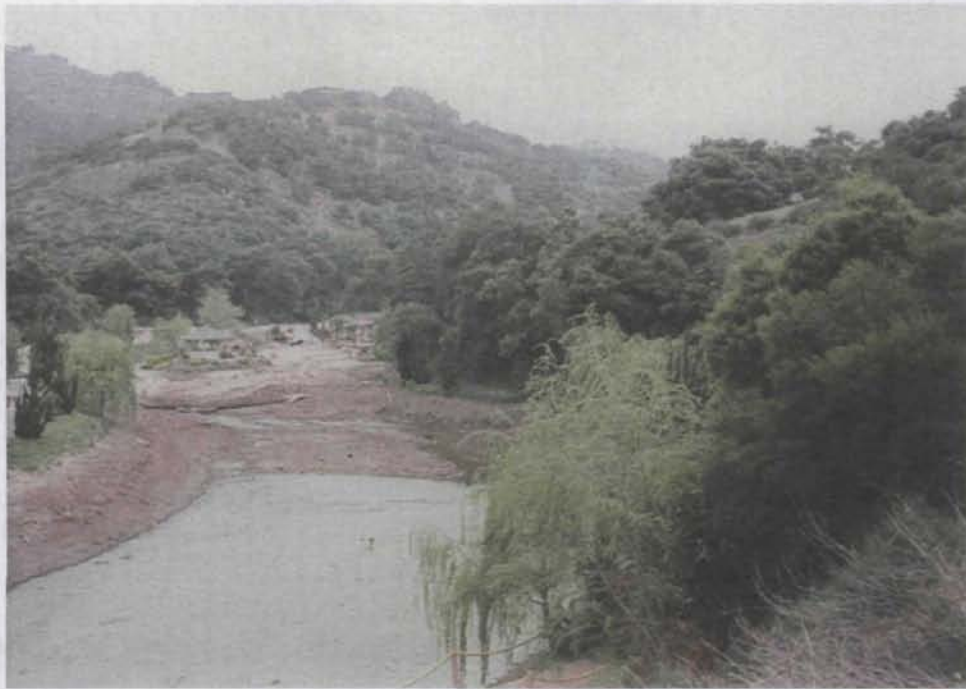
Photograph 4. View of the pond area after the flood of 1993.

Since the late 1970s there have been at least two major catastrophic flood events that have played a significant role both in the vegetation and configuration of the two main drainages that traverse the property, and in the subsequent human uses of the area within the floodplain. In 1979 a major flood occurred in Stewart Canyon which resulted in the destruction of several structures near the location of the pond. After this flood, a dyke was built that channeled the flow of the creek west of the pond and spa buildings. This dyke is still a prominent feature on the property. In 1993, after a large area up the drainage from the project site was cleared for agriculture, a severe winter storm triggered a flood and mud slide that again destroyed most of the structures in the drainage bottom and silted in the pond (See photographs in Appendix C). This flood resulted in over one million dollars in damage.

After the 1993 flood, the owners were required to clean up the damaged areas. They removed debris, channelized the drainage, restored the pond, enhanced existing flood control structures, and reconstructed the buildings.

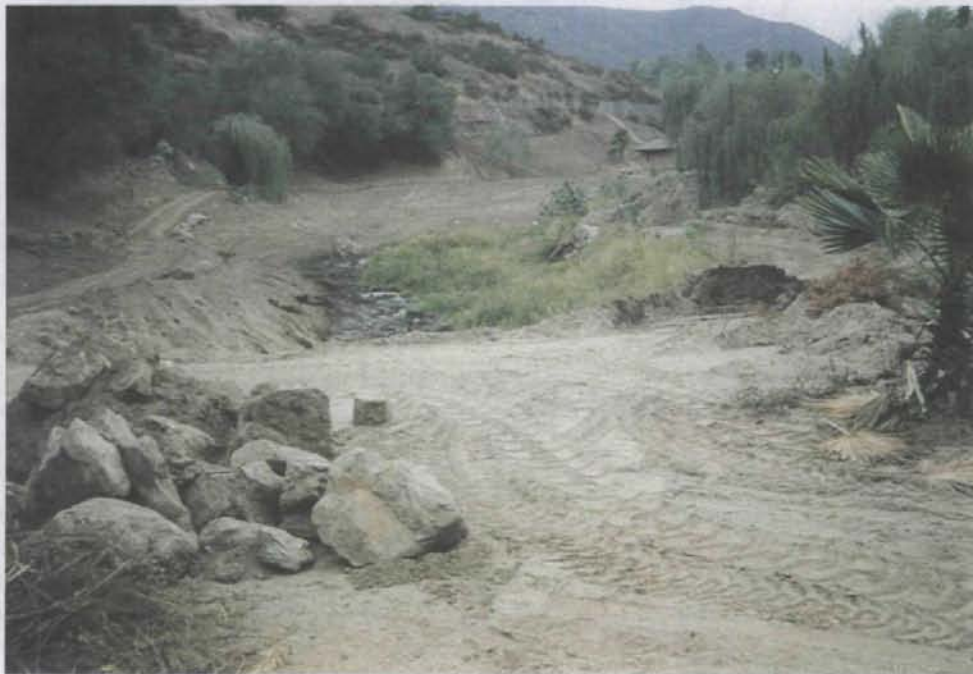
Photograph 5. View of the reclamation / restoration of the pond after the flood of 1993.

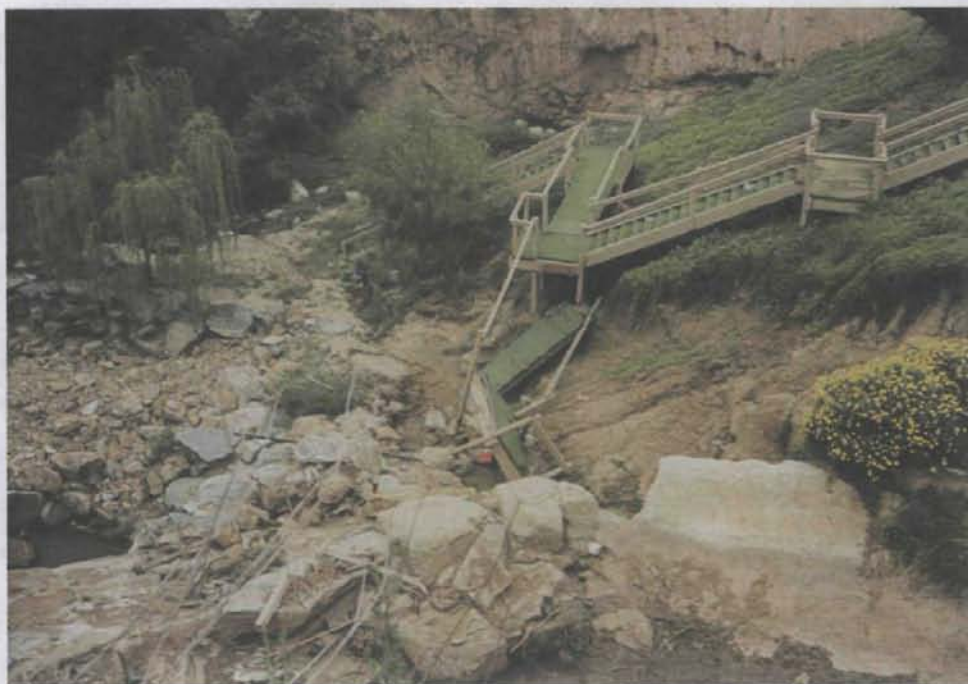
Photograph 6. View of the area below the pond after the flood of 1993. The stairway provided access to the long-established parking area south of the pond.

The site includes an area below the dam for the artificial pond that is occasionally used for overflow parking for events at Los Willows. Although portions of this area are located beneath coast live oak *Quercus agrifolia* trees, this area has been utilized for parking since the 1950's and the project does not propose to alter any of the existing long-standing parking uses on site. This area has been utilized for parking prior to the adoption of CEQA, the County's RPO, and adoption of federal and state endangered species acts and is not being altered by the proposed project. No mitigation is required for this parking area under CEQA since the project will not result in any new impacts associated with parking. Appendix F contains an affidavit provided by Ron Simpson of Fallbrook documenting use of the parking area since the 1950's.

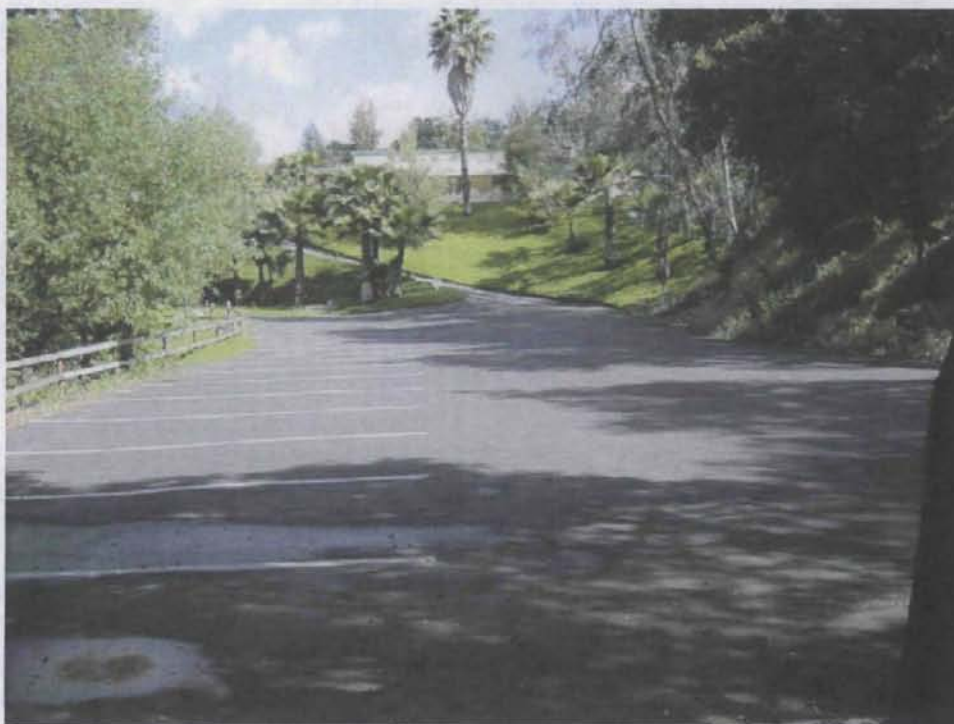
Photograph 7. Current view of the lower parking area showing configuration after the flood of 1993. The parking area was paved in 2001.

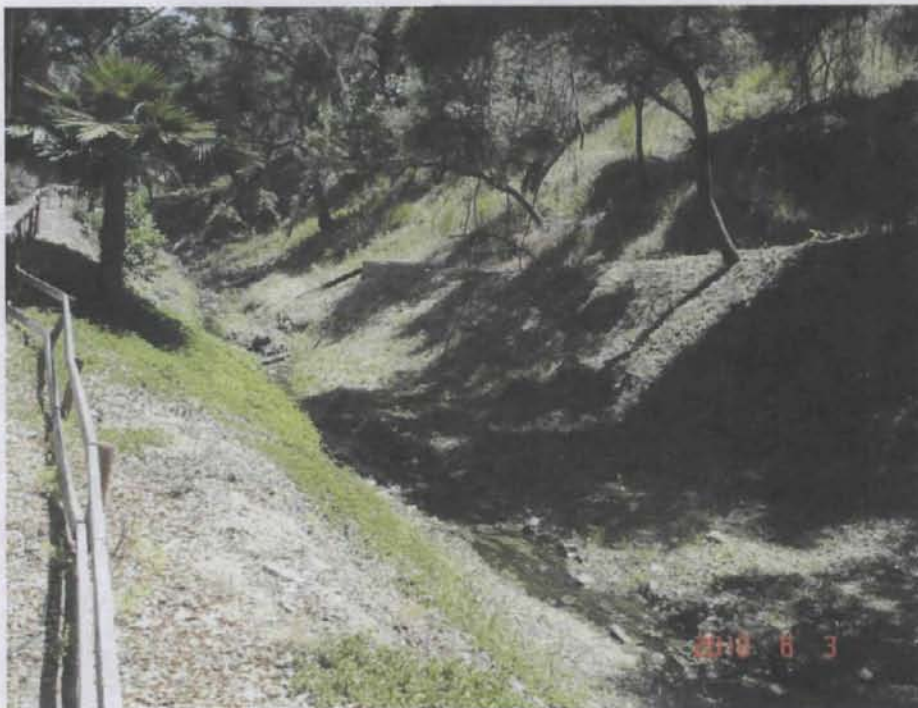
Photograph 8. Portion of drainage that runs parallel with the parking area near the south site boundary.

As noted above, the main drainage through the project site was channelized after several devastating floods. On the project site, this channel is essentially devoid of riparian vegetation (See Photographs 8 & 9). The southern 50% of the channel on the project site is surrounded by coast live oak trees.

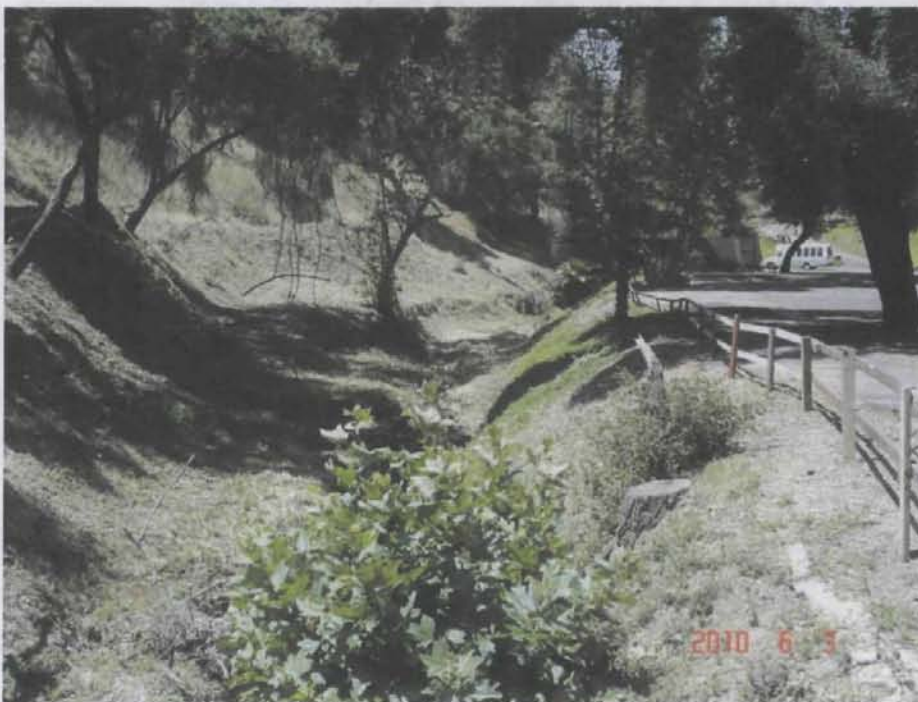
Photograph 9. Portion of drainage that runs parallel with the parking area near the south site boundary.

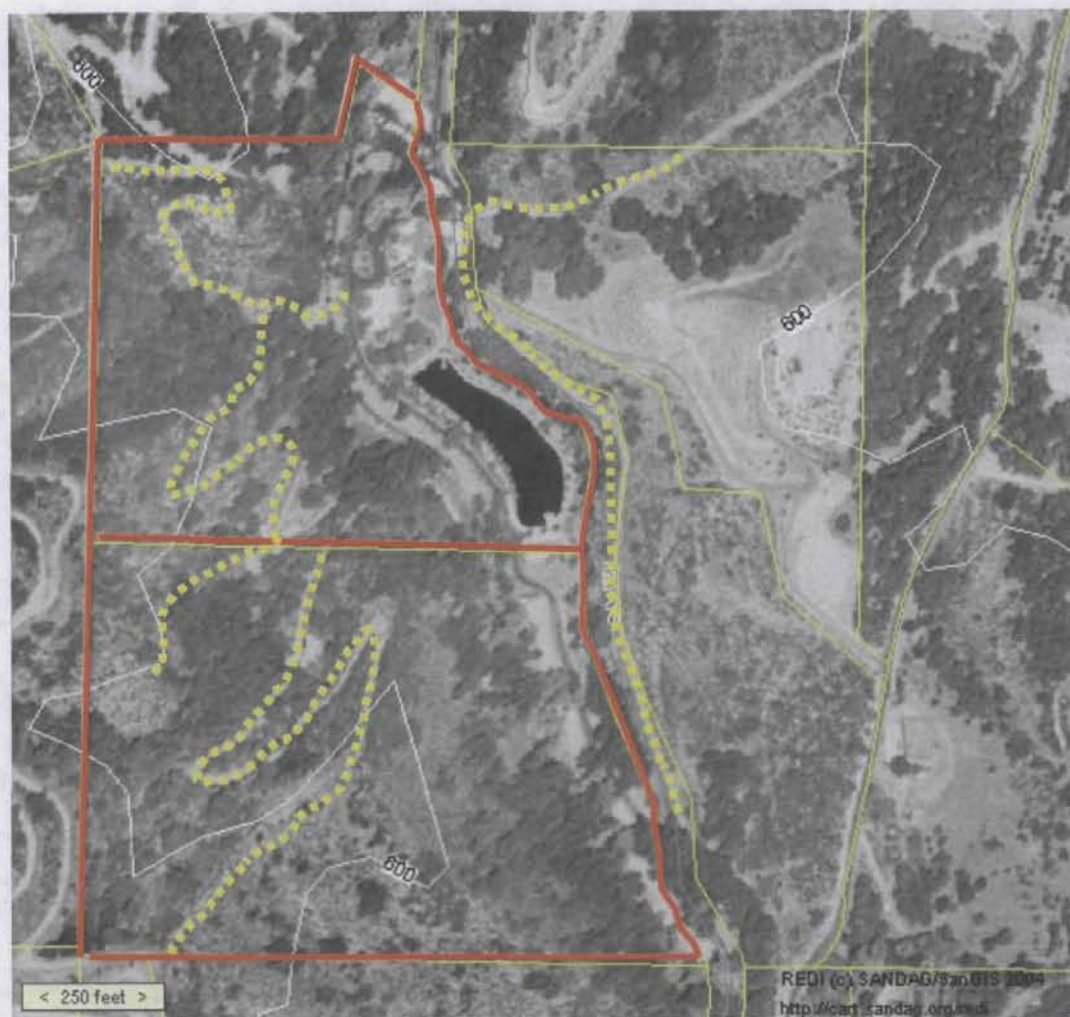
Figure 4. Close-up satellite photograph of project site (from SANDAG/SanGIS 2004), showing parcel boundaries for project site (outlined in red) and adjacent properties in yellow. Top of photo is true north. Yellow dotted line indicates route of gnatcatcher surveys.

I surveyed the site three times in conformance with current USFWS protocol guidelines. The surveys were conducted under the authority granted to me by USFWS permit # TE-788036. The surveys were conducted by slowly walking routes within the project site (See Figure 4). After stopping, listening, and observing at intervals of approximately 30 meters, taped Coastal California Gnatcatcher vocalizations were played for 30 seconds. After the vocalizations were played, an additional two minutes were spent observing and listening before moving to the next observation site. Weather conditions and time of day were appropriate for the detection of Coastal California Gnatcatchers (Table 1).
